Clutch Concentric Slave Cylinders (CSC)

Concentric Slave Cylinder Fitting Practice

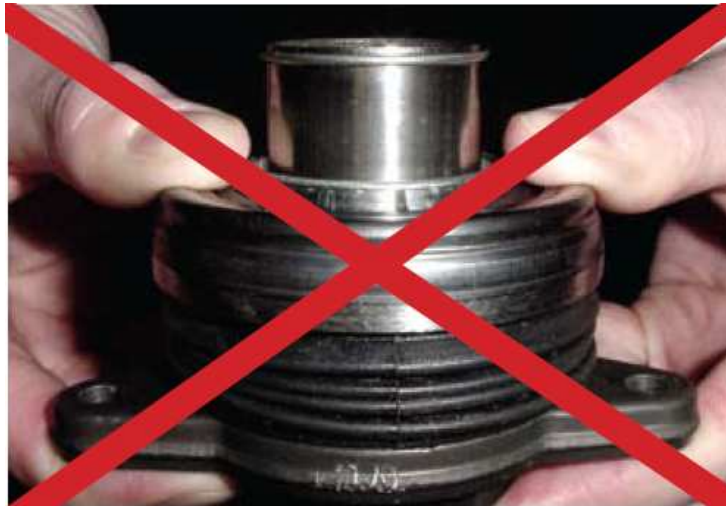
Fig.1

- 1) **Handling** – On removing the new CSC from the box, **DO NOT** compress the cylinder by hand to replicate the bearing movement.

By compressing the cylinder in this way the increased air pressure can cause the illustrated damage. Also, as the chamber is not pre filled with hydraulic fluid, damage will be caused to the internal seals due to excessive friction on the return stroke.

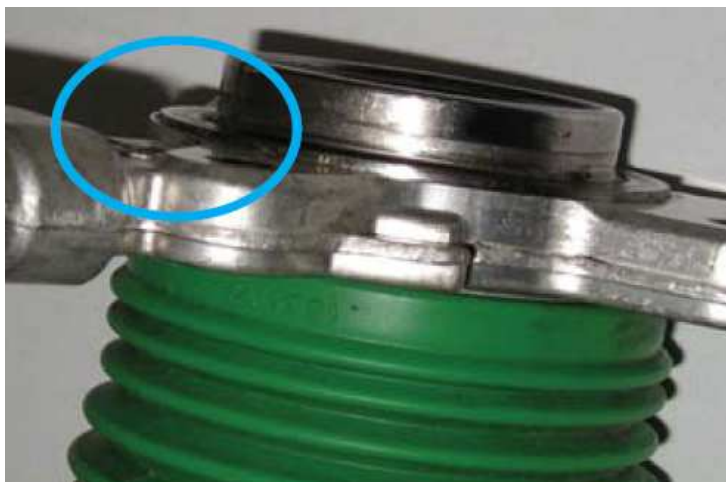
Fig.2

2) **Cleanliness** – the area in which the CSC is positioned needs to be totally clean and free of debris. It must locate cleanly and squarely on the gearbox casing and any rubber face seal or sealant should be used in accordance with the manufacturer’s instructions. If the CSC is not seated correctly the back face can push out as seen in **Fig.2 & Fig.3**.

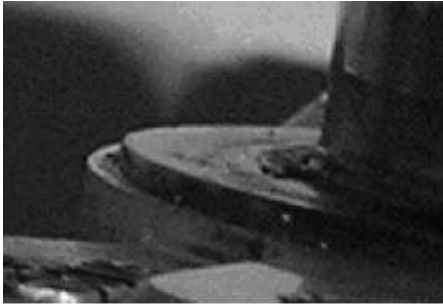
Fig.3

The CSC has not been seated squarely and hydraulic pressure has forced the back plate out of position – e.g Mondeo VCC 4

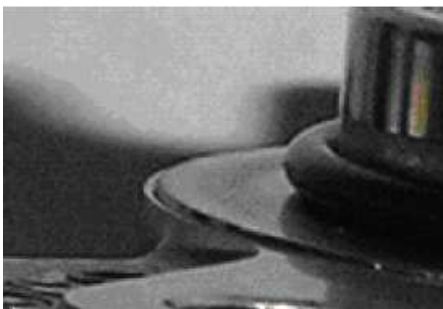
Fig.4

NEW CSC – No damage to the back face plate

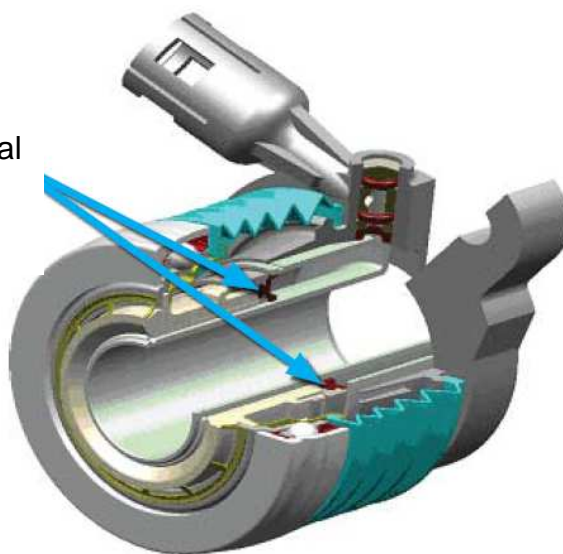
Fig.5

Main Chamber seal

3) **Fitting** – gently slide the CSC over the gearbox input shaft and slightly rotate it to ensure the correct location on the gearbox case. Evenly torque down the fixing bolts using a torque of between 18 – 12Nm, dependant upon the manufacturer’s specification.

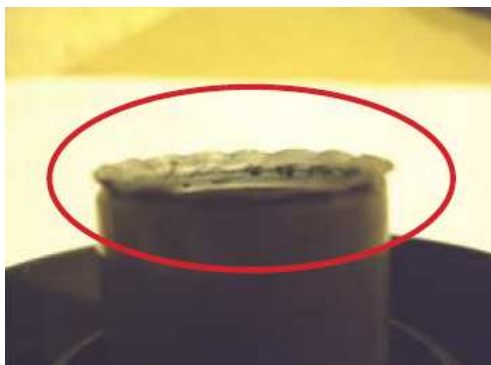
Fig.7

6) **Distortion** to the retaining ring as shown below is a result of the bearing exceeding its maximum travel. The bearing has been forced against the ring during the bleeding process. This also damages the piston internal seal resulting in loss of fluid past the seal.

To avoid the cylinder being over stroked, the pedal should be depressed and then released slowly to allow the cylinder to return to rest before the pedal is depressed again. In some cases, the bleed nipple / pipe may need to be locked off after every downward stroke of the pedal, until some pressure in the system is achieved. This process may need to be carried out numerous times before some pressure is felt in the pedal. This is a common action required on Ford Fiesta/Puma/Ka when bleeding the system, as an air lock can occur within the clutch master cylinder. We do not recommend the use of power bleeding systems, as some systems run at a high air pressure. This can invert or roll the internal seal resulting in immediate fluid loss.
